# STRUCTURAL MONITORING OF ARCHEOLOGICAL SITES BY LASER MEANS: THE CASE OF THE LAST REMAINING COLUMN OF *HERA LACINIA* AT CAPO COLONNA, CALABRIA, ITALY

Lorenzo Grassi <sup>a</sup>, Diego L. Gonzalez <sup>b,c</sup> and Maurizio Conti <sup>d</sup>

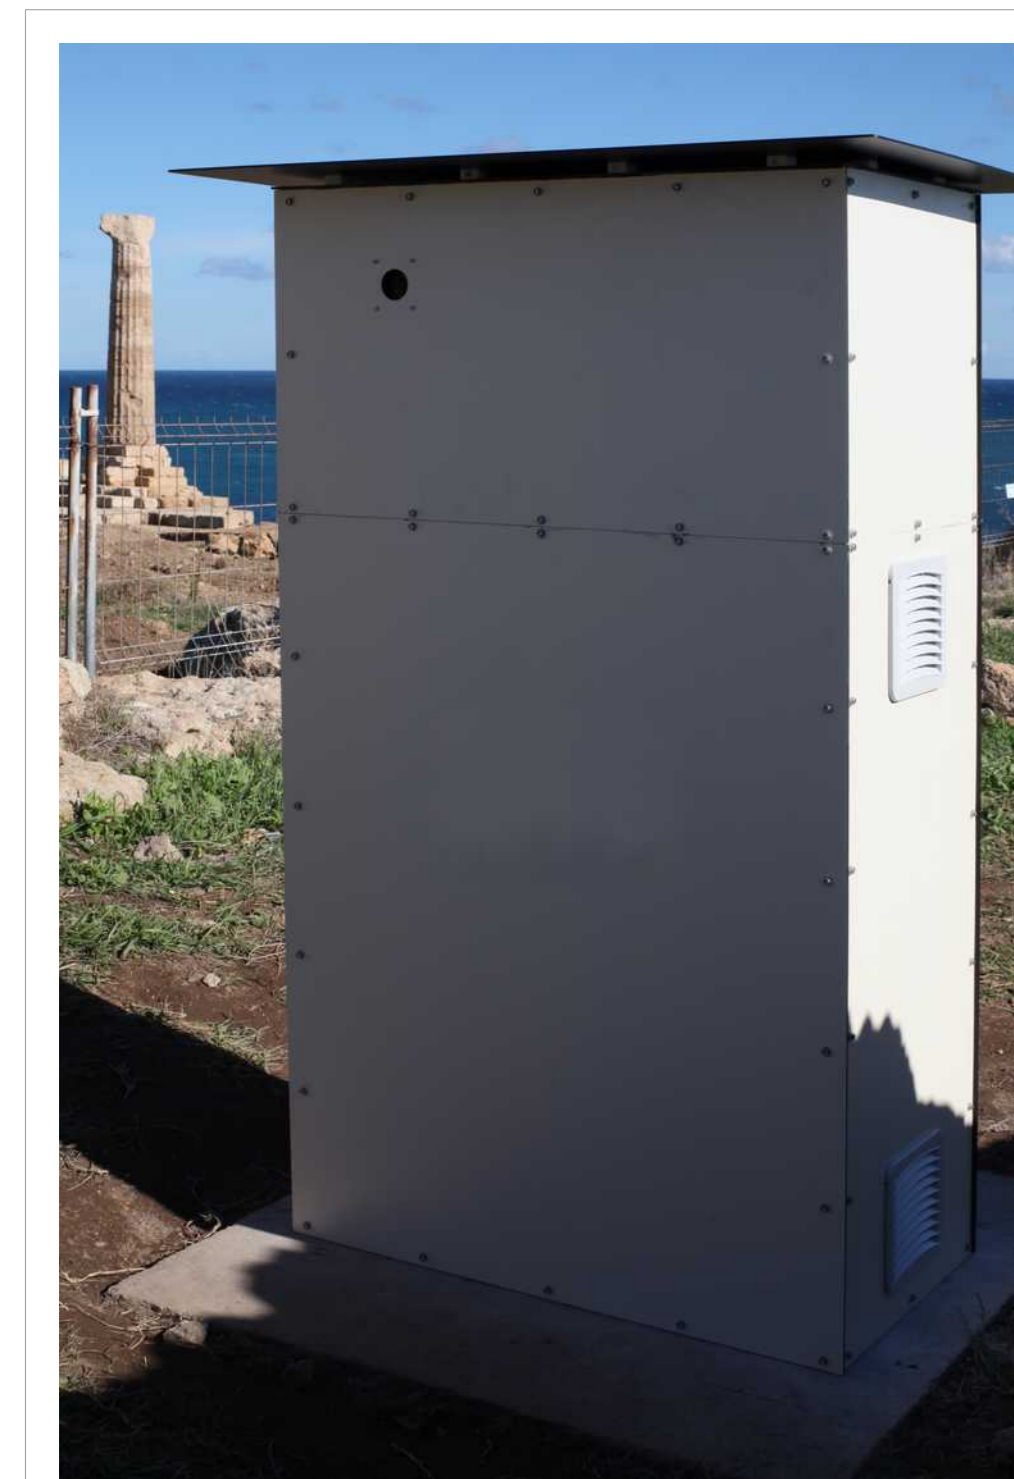
Figure 4: The protection box

The entire system was designed to work outdoors under unfavorable environmental conditions such as strong winds, salt spray, strong sunlight, rain, etc. The system was conceived for attaining robustness to climate threats, vandalism, and also to energy and communication fails while maintaining an efficient and cheap implementation. Each of the three distance meters is mounted on a two axes micrometric pointing system; all pointing systems are fixed on a robust common platform, made of stainless steel AISI 316 and anchored to a reinforced concrete plinth rooted in the soil. The pointing system is designed around commercial rotary tables and was designed and built by a precision machine shop. The metal components not made of stainless steel were protected against oxidation with specific surface treatments. A box made with frame in L-profiled, also in stainless steel AISI 316, and closed by wafer panels of composite material, protects distance meters and the support structure from weather attacks. The box is equipped with ventilation mouths with protective filters and the cover is similar to a ventilated-roof in order to reduce, in the interior, the irradiation due to the exposure to the sun on the outer cover. The box is mechanically and spatially separated from the platform on which the distance meters are mounted in order to decouple the latter by the mechanical action of the weather, such as the wind or the thermal expansions, which act on the outer protection structure. On the walls of the box some holes have been made for the passage of the laser beams. The holes are also provided with the necessary protection from wind and rain.
